CWA COMPLIANCE EVALUATION INSPECTION REPORT
U.S. ENVIRONMENTAL PROTECTION AGENCY, REGION 5

Compliance Evaluation Inspection

KJMM Pork & Grain – Range Farm
11405 Range Lane
Marissa, IL 62257

August 27, 2012

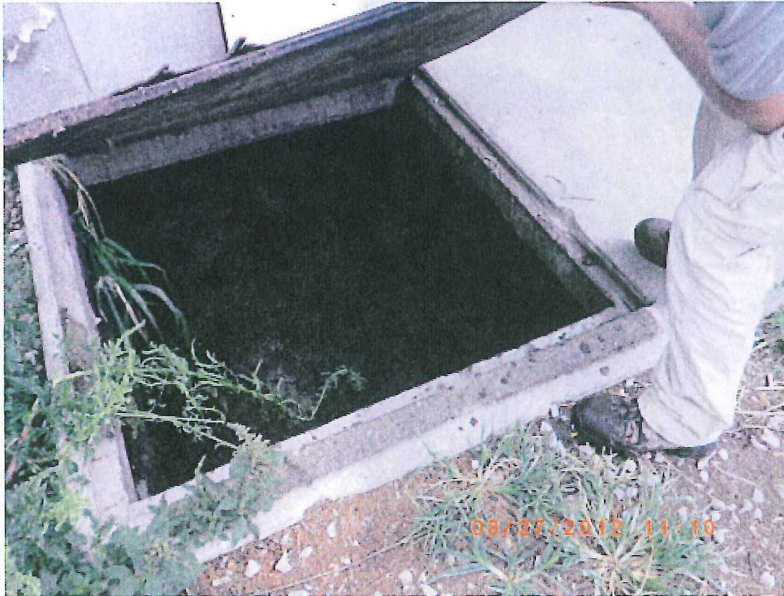
IMGP0887: Pit for Cable Bay has storage capacity left.

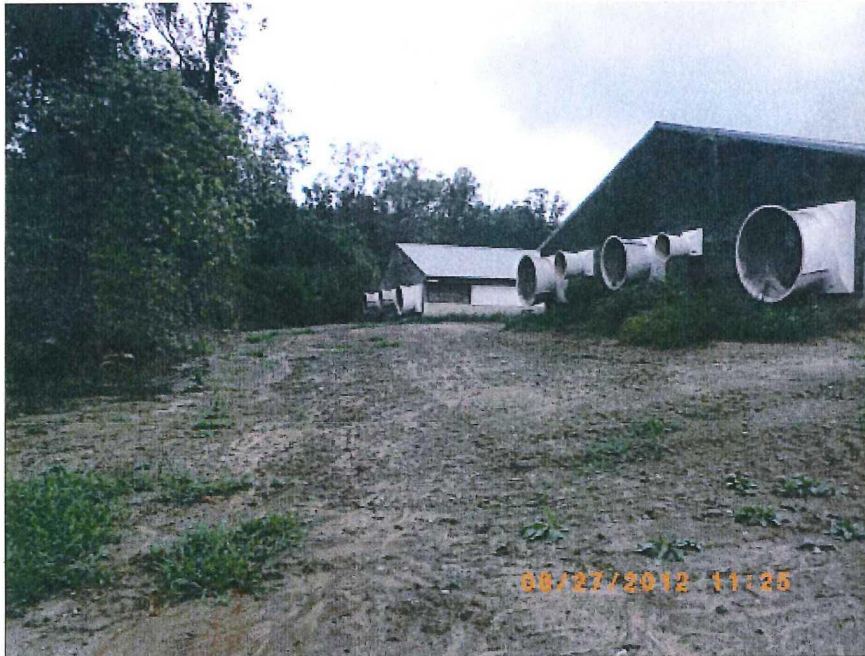
After walking to the north end of the facility, EPA observed the facility between the barns then headed south along the west side of Barn #6 though Barn #1. EPA noted that the ground around the barns on the west side of the facility was denuded of vegetation. Pollutants from the barn fans had the potential to flow with precipitation to the intermittent unnamed tributary located west of the facility. This intermittent unnamed tributary was located approximately 0.10 miles to the west.

IMGP0896: Ground surface is denuded of vegetation on west side of facility.
 Location: Southwest of Barn #5
 Facing: North
 Date/Time: 08/27/12 11:25 A.M.

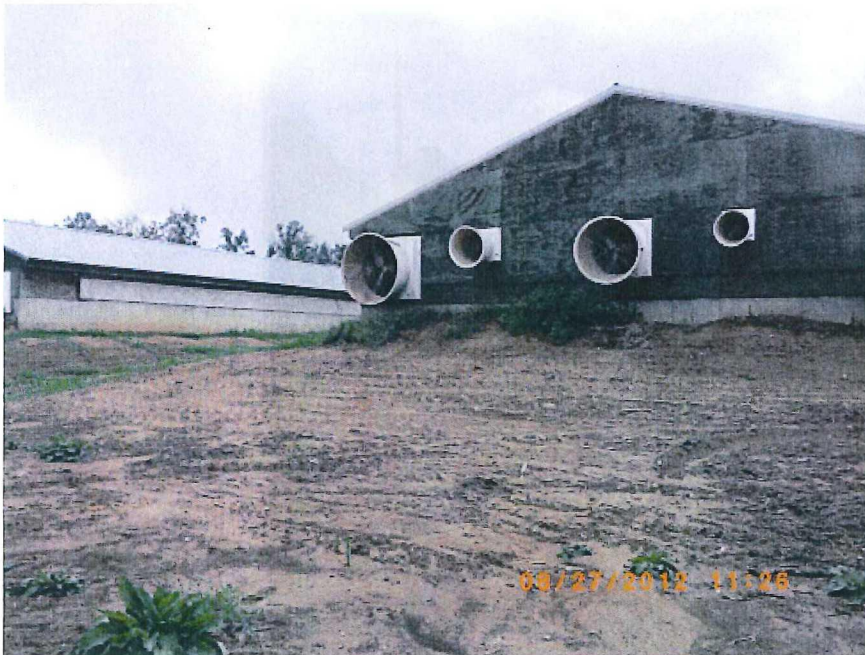
IMGP0897: Ground under the barn fans is denuded of vegetation.
 Location: West of Barn #4
 Facing: Northeast
 Date/Time: 08/27/12 11:26 A.M.

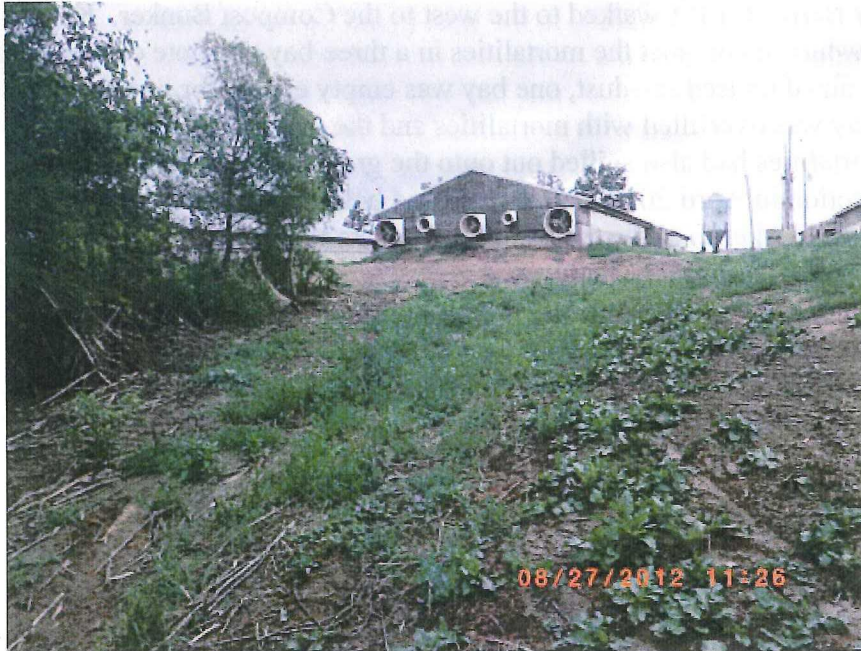
IMGP0898: Hillside to the west of Barn #4. Without vegetation, fan discharge can flow down the hillside during precipitation events.

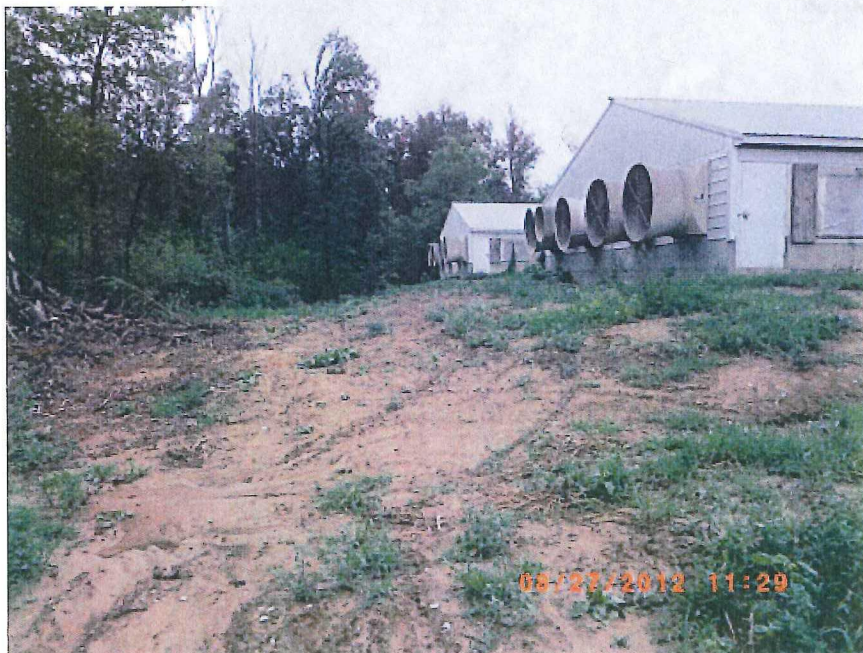
IMGP0899: Ground surface west of Barns #5 and #6 is denuded of vegetation.

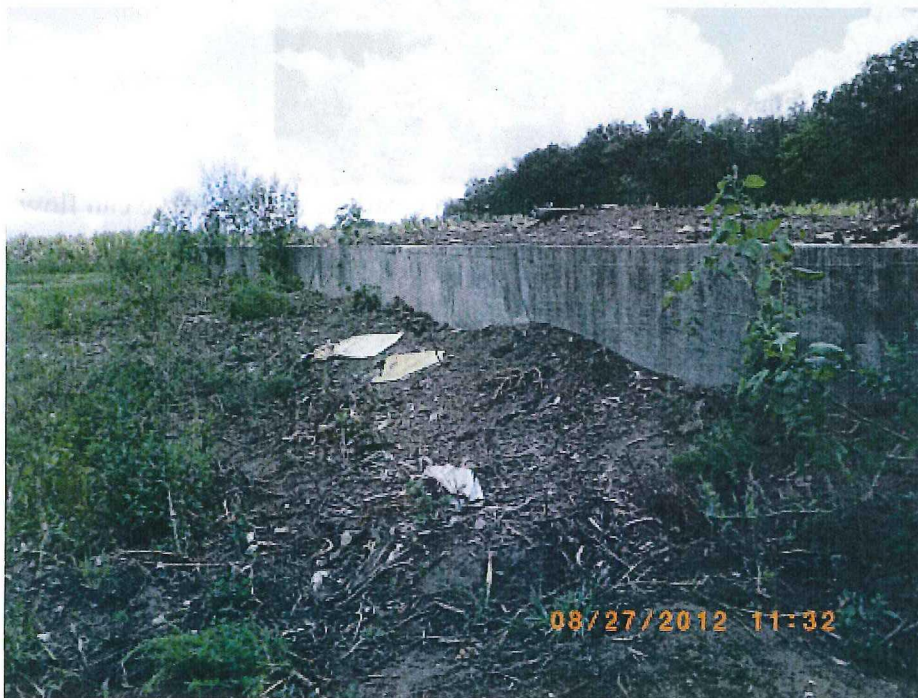
After passing south of Barn #1, EPA walked to the west to the Compost Bunker. KJMM Pork & Grain uses sawdust to compost the mortalities in a three-bay concrete composting bunker. One bay contained unused sawdust, one bay was empty except for some process wastewater and one bay was overfilled with mortalities and the mortalities were not properly covered. Mortalities had also spilled out onto the ground around the Compost Bunker. In their inspection in April 2012, IEPA identified holes in the concrete on the east side of the Compost Bunker to allow the compost leachate to flow out. The facility has since plugged the holes. A drainage pathway was observed in the trees to the north. EPA walked the length of the drainage pathway until it ceased to be a clearly defined channel. There was no water in this pathway on the day of the inspection. EPA discussed with Mr. Schilling the potential for mortality leachate to flow with the storm water to the intermittent unnamed tributary to the west.

IMGP0900: East wall of Compost Bunker. Compost Bunker is overfilled and composting animal carcasses are on the ground around the bunker.

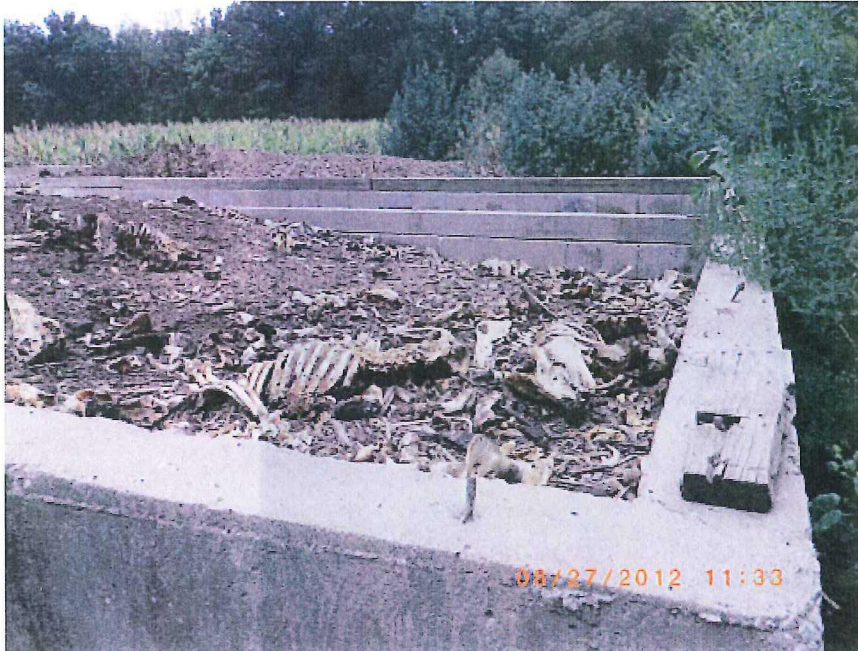
IMGP0901: Mortalities in Compost Bunker are not properly covered.

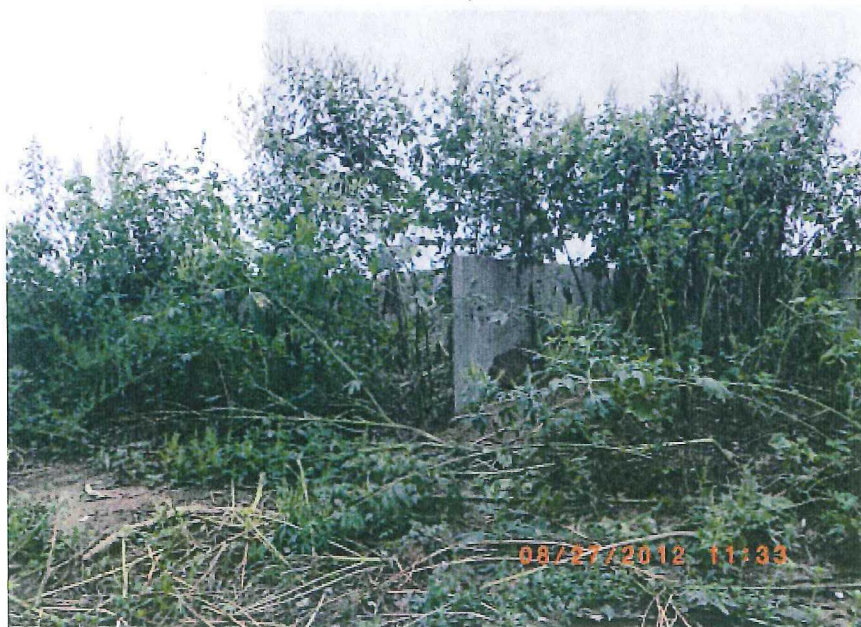
IMGP0902: North side of Compost Bunker. Previously, there was a hole in the bunker on the east side to allow leachate from bunker to flow to the north. Facility owners have since closed the hole.

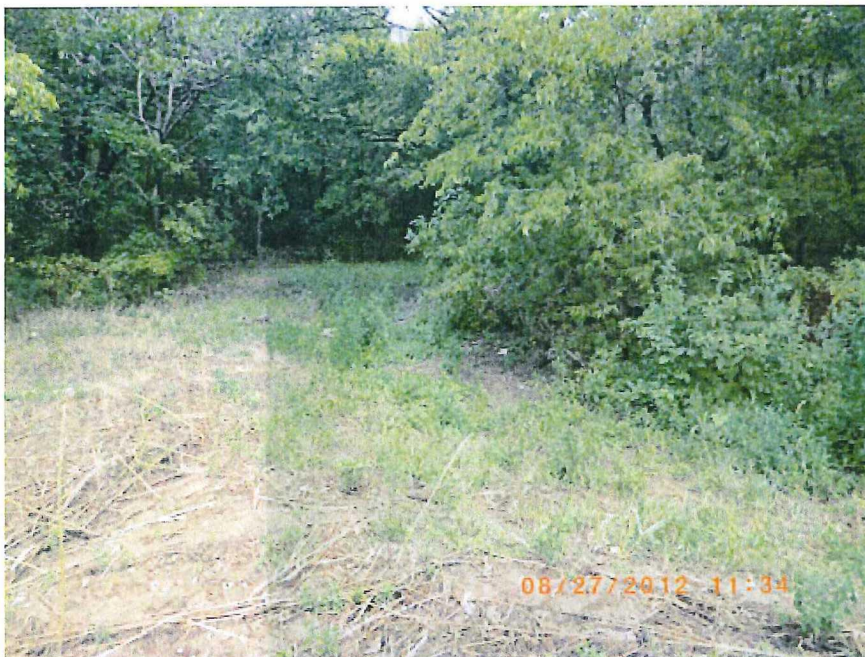
IMGP0903: Drainage pathway that precipitation would follow after picking up pollutants from compost material on the ground around Compost Bunker.

1. Process wastewater from the Compost Bunker could flow with storm water from precipitation events to the intermittent unnamed tributary.

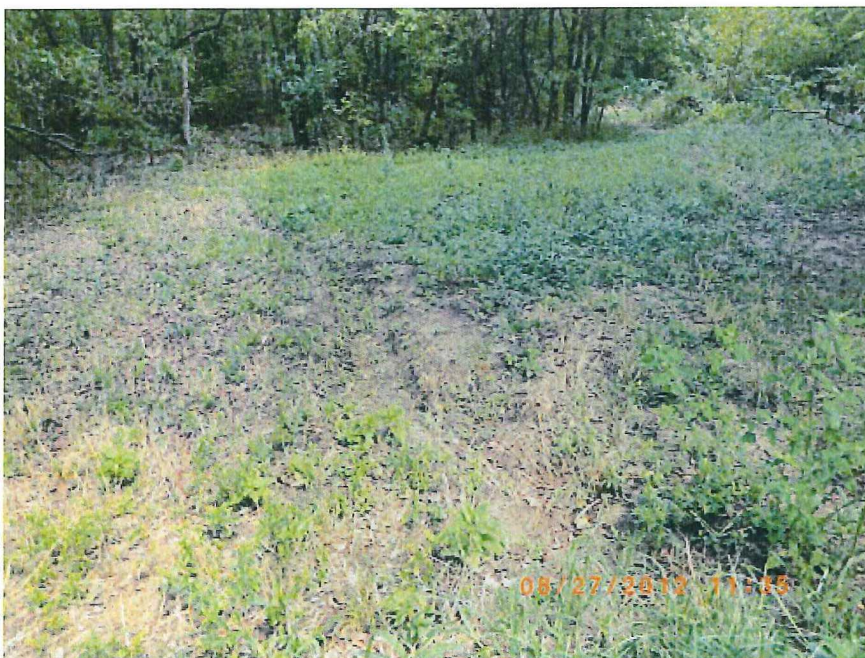
IMGP0904: Channelization in drainage pathway leading from Compost Bunker area.

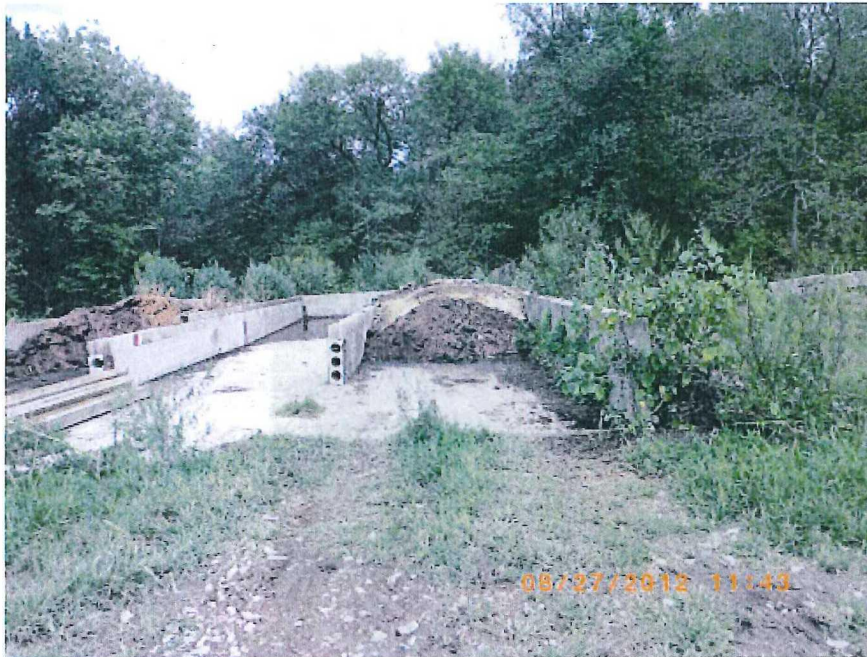
IMGP0907: Compost Bunker is not maintained properly. One bay is not used, while others are overfilled. Mortalities are not covered.

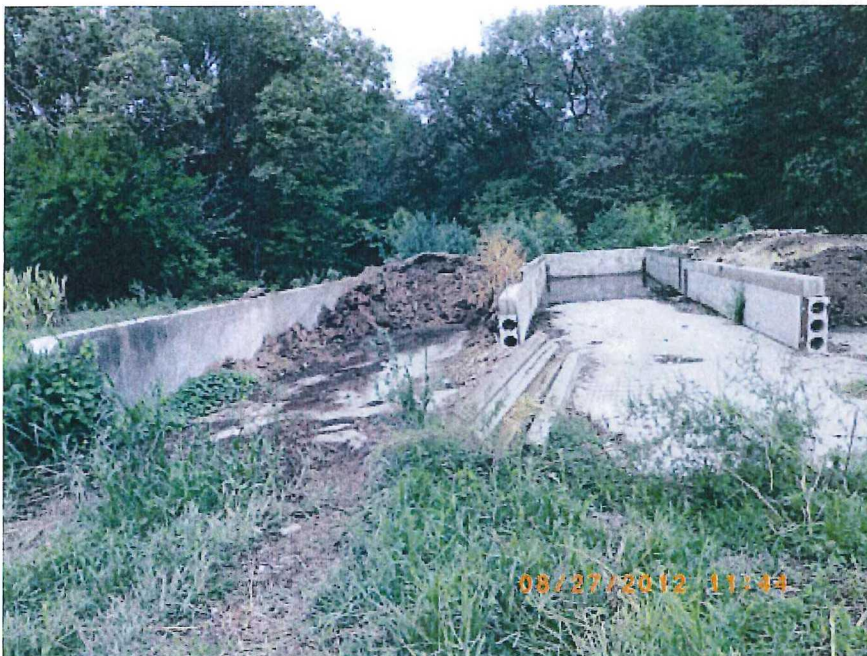
IMGP0908: Compost Bunker has a bay that is not being used while other bays are overfilled. Sawdust is stored in the left bay, mortalities composted in the right.

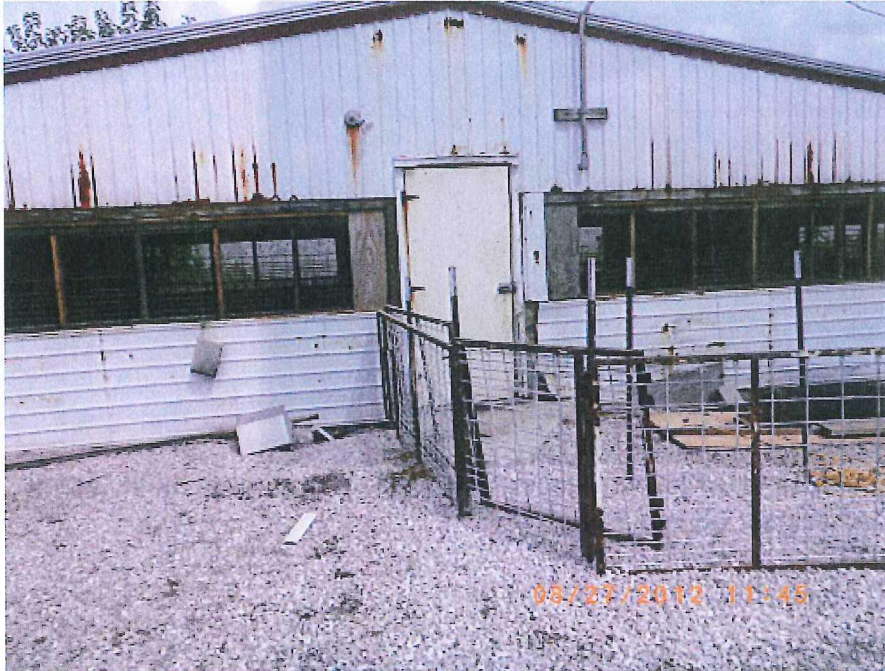
Leaving the compost area, EPA walked east and observed the White Barn. During the IEPA inspection in April 2012, the pit below this barn was overflowing onto the ground. The facility owners have since pumped down the pit and cleaned up the manure around the barn.

IMGP0909: White Barn load in/out area. Previously, this barn's pit had overflowed onto the ground around the barn. No manure was evident on the ground during this inspection.

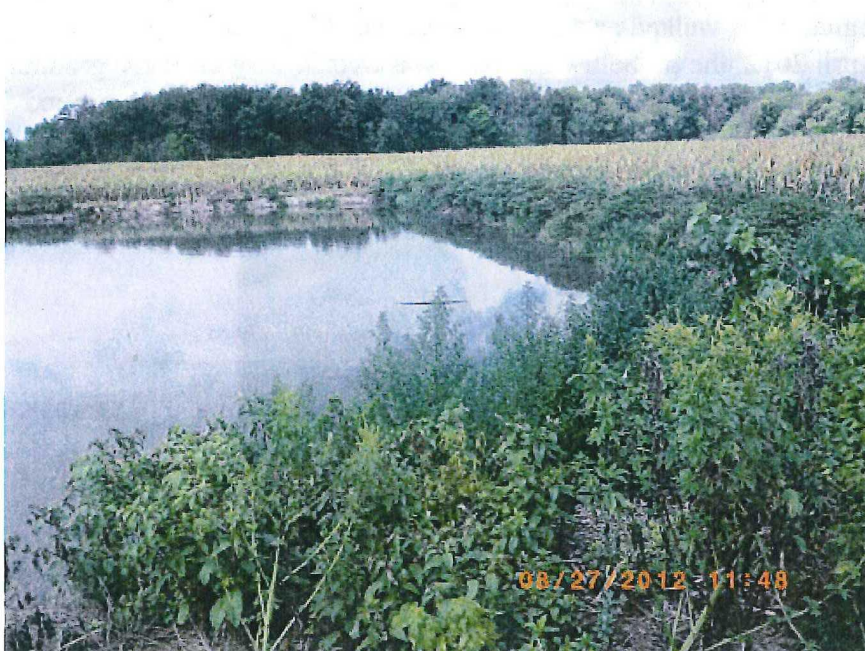
EPA then walked south to observe the Stage 2 Manure Pond. The berm of this pond had a small amount of woody growth that needed to be removed and vegetation that needed to be mowed. Mr. Schilling identified for EPA the inflow pipe from the Stage 1 Manure Pond into the Stage 2 Manure Pond, the two outflow pipes to the Stage 3 Manure Pond and another inflow pipe of unknown origin. By the position and orientation of this pipe, Mr. Schilling believed the pipe to originate in the unused barns west of the Cable Bay.

IMGP0910: Stage 2 Manure Pond has vegetation that needs to be mowed on the berms.
 Location: Northeast of Stage 2 Manure Pond
 Facing: West
 Date/Time: 08/27/12 11:48 A.M.

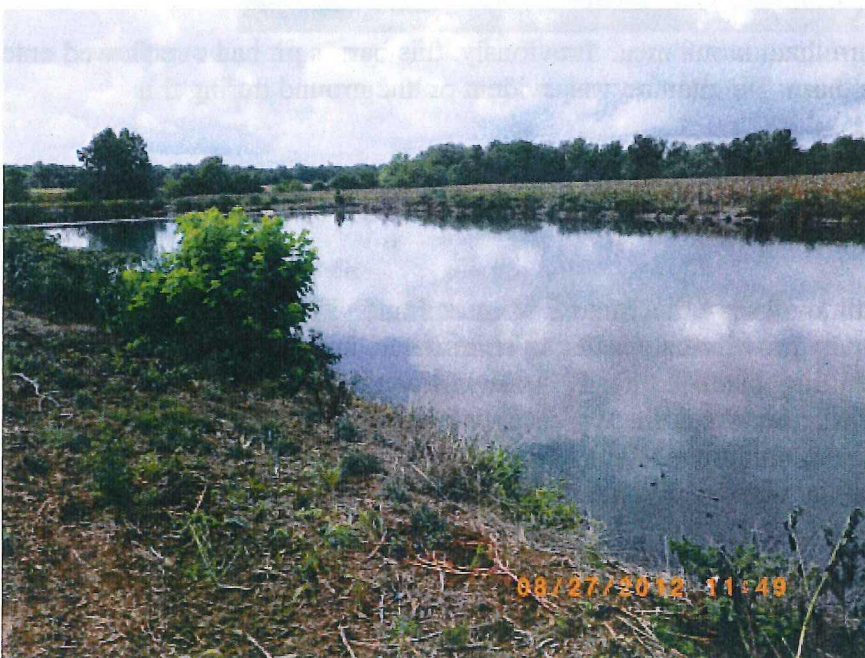
IMGP0911: Stage 2 Manure Pond has a small amount of woody growth that needs to be removed from the berms.
 Location: Northeast of Stage 2 Manure Pond
 Facing: Southwest
 Date/Time: 08/27/12 11:49 A.M.

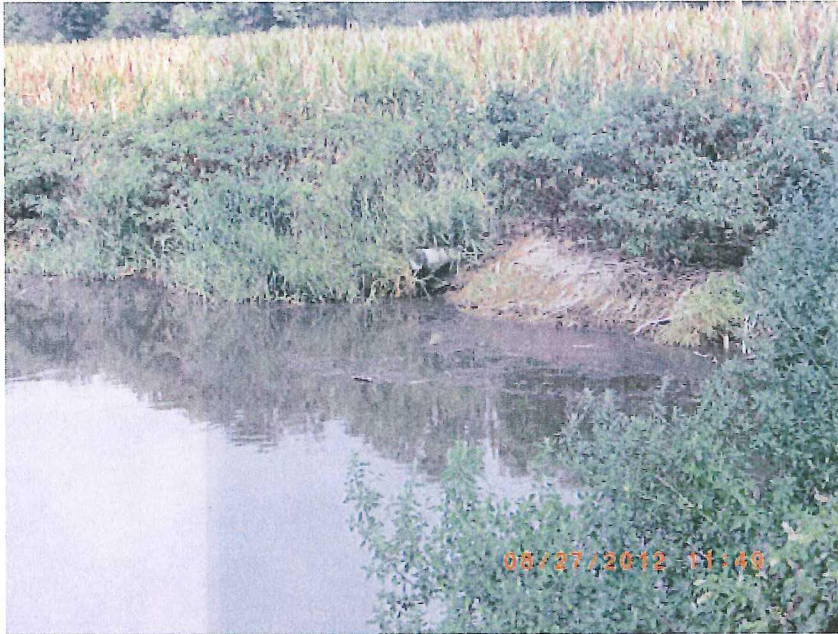
IMGP0912: Inflow pipe from Stage 1 Manure Pond to Stage 2 Manure Pond. Berms need to be mowed and woody growth removed.

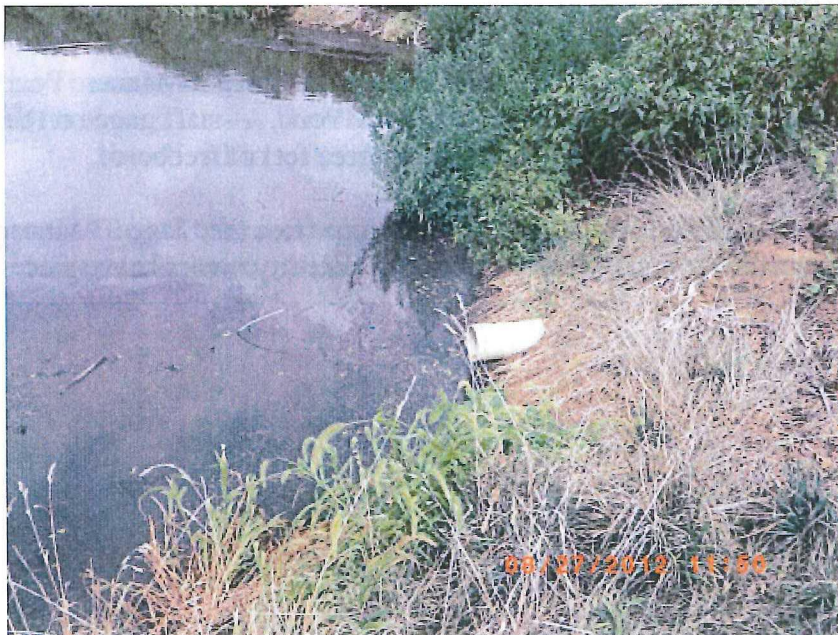
IMGP0913: Another pipe to Stage 2 Manure Pond. Facility representative did not know where this pipe originates. It could possibly originate from old barns west of Cable Bay that are not used to house animals anymore.

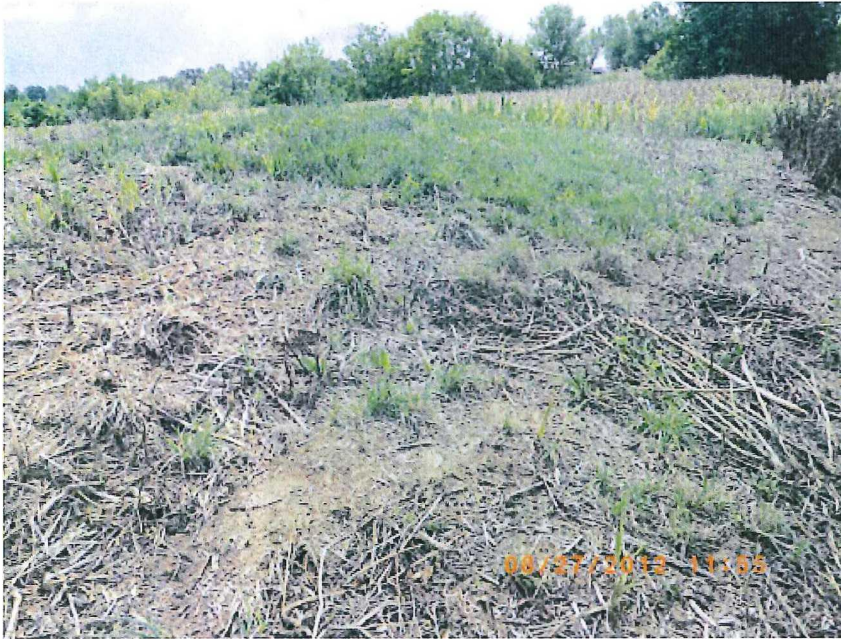
In their April 2012 inspection, IEPA inspectors identified a pipe from the Stage 3 Manure Pond to the intermittent unnamed tributary just to the south. Facility owners have since removed the pipe.

IMGP0917: A pipe from the Stage 3 Manure Pond used to exist in this location. The pipe discharged manure from the Stage 3 Manure Pond to an intermittent unnamed tributary. The facility owners have since removed the pipe.

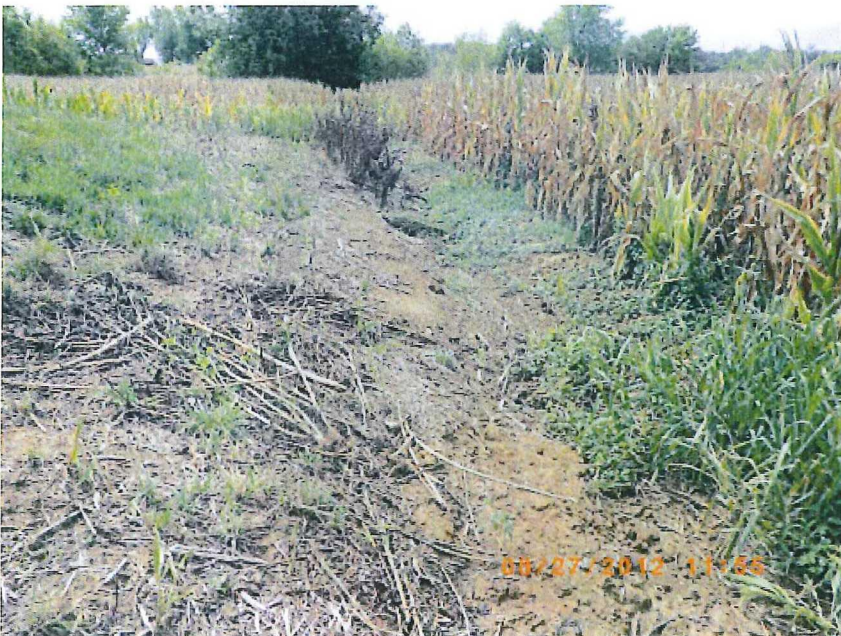
IMGP0918: Intermittent unnamed tributary that previously received manure from the Stage 3 Manure Pond.
